State of Alaska
Department of Fish and Game
Nomination for Waters
Important to Anadromous Fish

Name of Waterway Red Cove Lake USGS name ✓ Local name 11200

**Special Report To
Aleutians East Borough
(Cooperative Agreement No. 93-003)**

**Sand Point Area Stream
Clearance Feasibility Study**

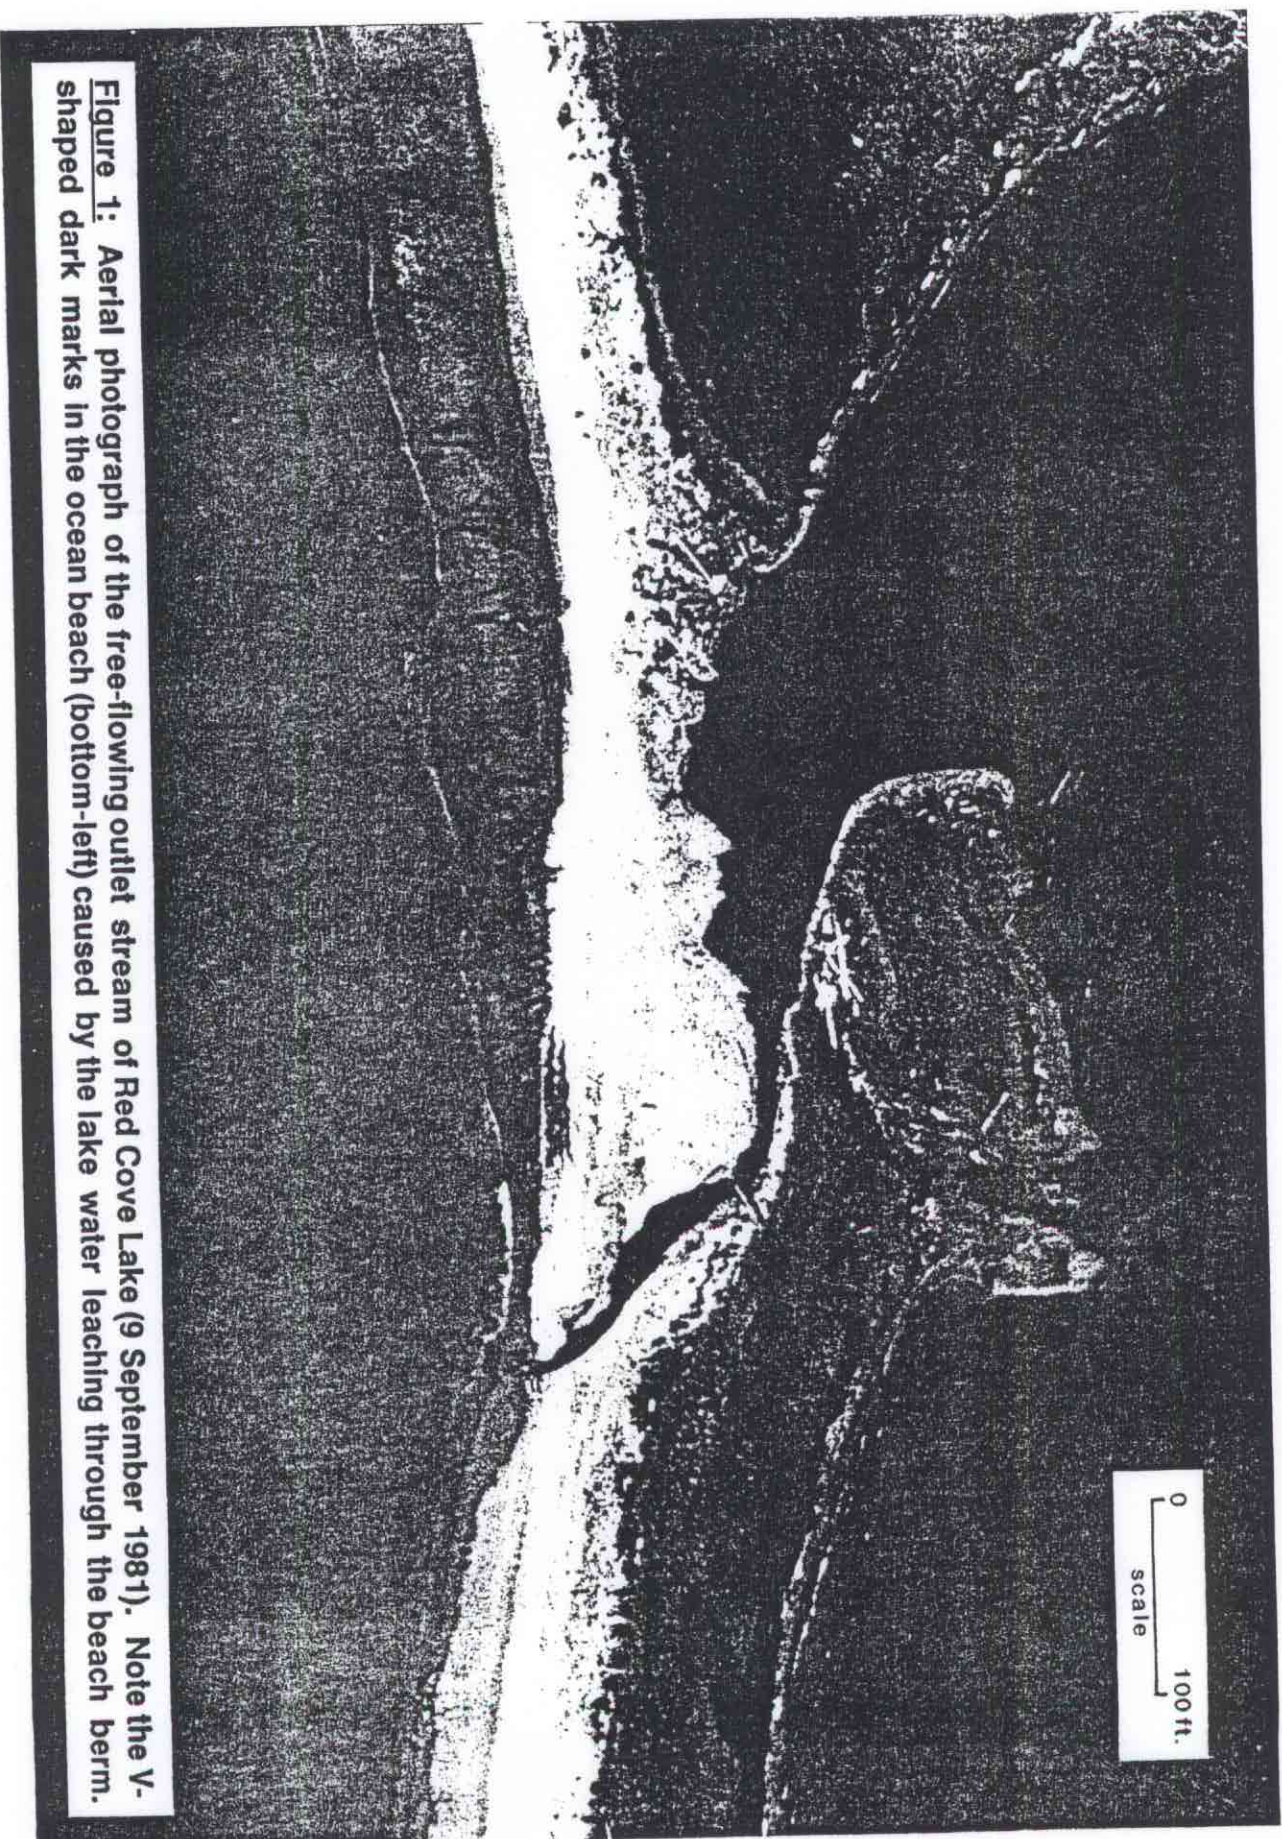
Figure 1: Aerial photograph of the free-flowing outlet stream of Red Cove Lake (9 September 1981). Note the V-shaped dark marks in the ocean beach (bottom-left) caused by the lake water leaching through the beach berm.

push rocks and gravel from the sea side onto the beach to raise and reinforce the beach berm, especially during a high tide. Because the lakes have relatively small drainage basins, the accumulation of fresh water inside the beach berms may not provide sufficient pressure to maintain the lake outflow during these events. In addition, because of the heavy surf action, the "fines" are sorted and extracted from the beach berm materials. It is evident in Figure 1 that Red Cove Lake drains through the beach berm, even when a free-flowing outlet stream exists.

The Red Cove Lake outlet (Figure 1) on 14 September 1992 was effectively blocked to prevent anadromous salmon migration by large, cobble-size (20-30 cm), smooth surface rocks (Appendix A) (Figures 2, 3, and 4). Water from the lake was percolating through the rocks at several points along the beach area adjacent to the lake. Adult coho salmon were observed jumping in the bay adjacent to the lake, and young salmonid fry were observed in the lake near the former lake outlet. It is apparent however, that under natural conditions, this blockage may be intermittent. Hauser (Appendix A) reported during an earlier investigation that the outlet stream from Red Cove Lake was free-flowing. It was approximately 6-8 in. deep and 10-12 ft. wide. Adult coho salmon were observed in the lake at that time. Also, on 9 September 1981, the outlet stream from Red Cove Lake was well-defined and functional (Figure 1).

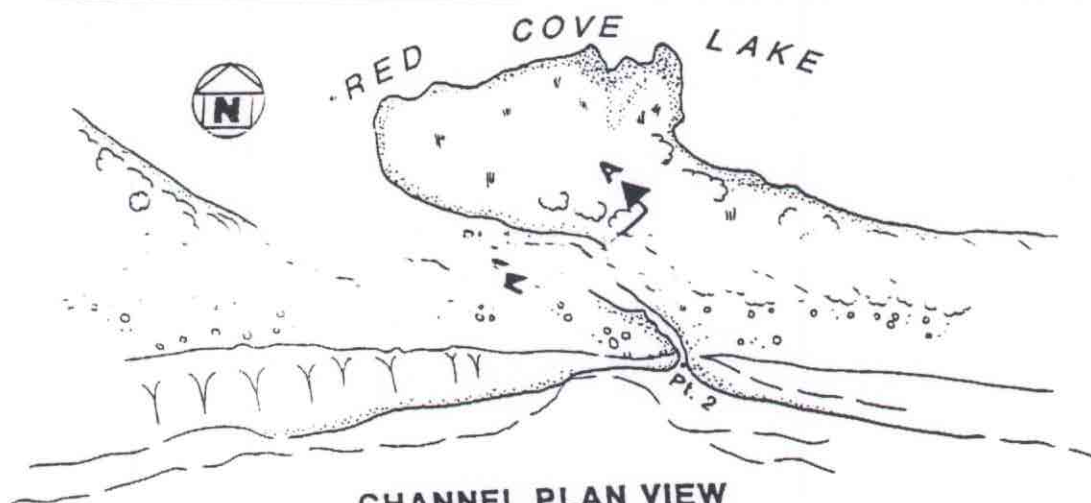
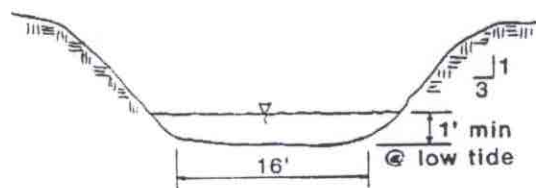
CHANNEL PLAN VIEW

SECTION A-A
NOT TO SCALE

Figure 5: Plan for channel clearance for Red Cove Lake outlet stream.

It was concluded from the survey that a channel could be recreated by removing the rocks. The recommended method to recreate the channel is with the use of a small backhoe (e.g., Case 580 or equivalent) or small bulldozer (e.g., a Caterpillar D4 or equivalent). The channel should be approximately 70 m (230 ft) long and 5 m (16 ft) wide at the base (with banks sloped at 1:3) to create up to about 0.3 m (1 ft) of water depth flowing in the outlet stream to allow passage by the adult salmon (Figure 5). Because of the open exposure of the site and repeated storms, no structure is recommended to maintain a permanent opening. The site should be surveyed at least

Common sense and cost should be the driving factors in those methods employed to clear the system on an annual basis. The location of the channel should, most likely, follow the pathway wherever a natural free-flowing stream did exist. It will be expedient to excavate a shallow channel across the lowest elevation of the beach berm to initiate water movement and to allow the flow of water to expand the newly opened stream channel. As the water flows, the channel will enlarge and the materials returned to the ocean. Machine or hand labor may be required to deepen shallow portions of the stream, particularly during the adult migration.

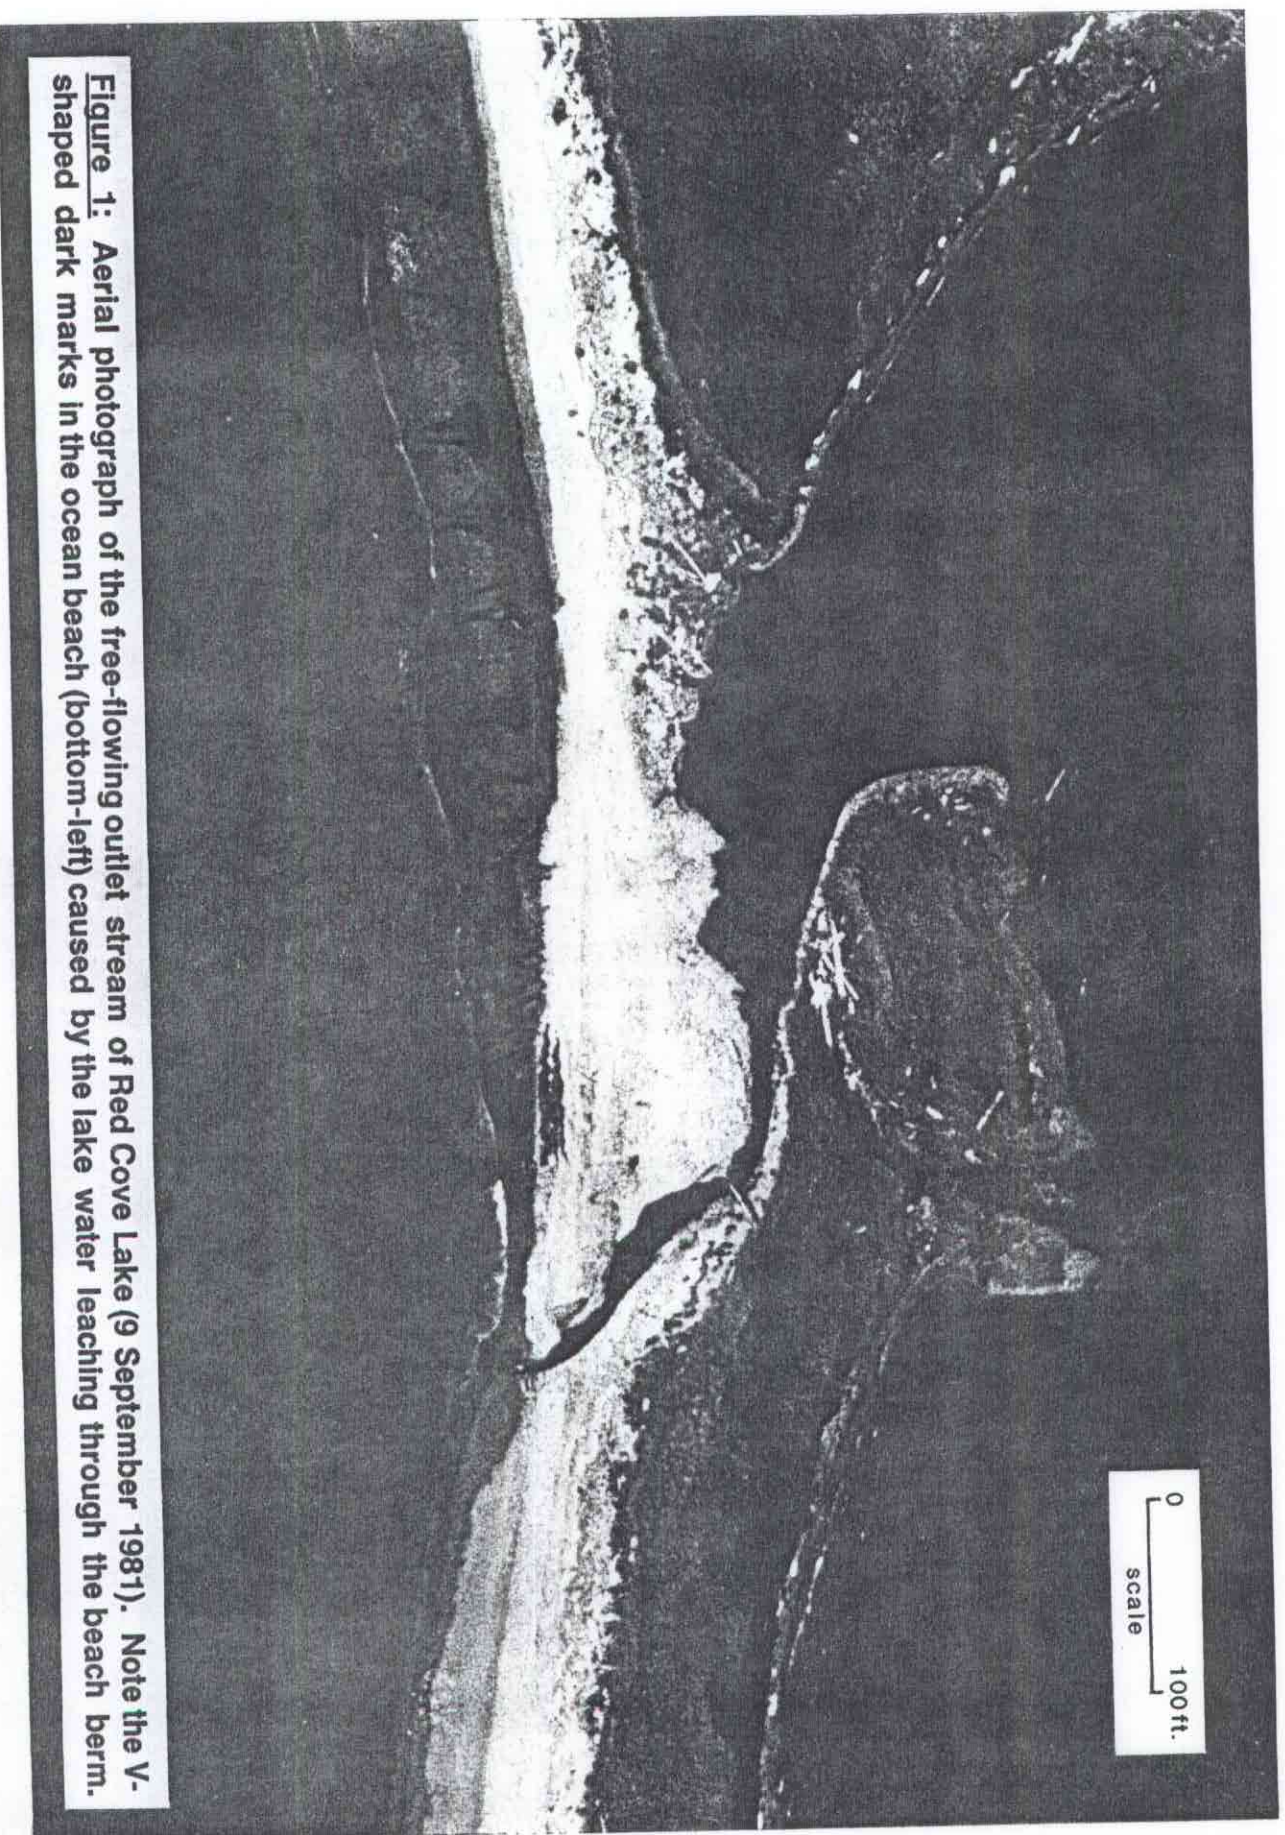
Figure 1: Aerial photograph of the free-flowing outlet stream of Red Cove Lake (9 September 1981). Note the V-shaped dark marks in the ocean beach (bottom-left) caused by the lake water leaching through the beach berm.

push rocks and gravel from the sea side onto the beach to raise and reinforce the beach berm, especially during a high tide. Because the lakes have relatively small drainage basins, the accumulation of fresh water inside the beach berms may not provide sufficient pressure to maintain the lake outflow during these events. In addition, because of the heavy surf action, the "fines" are sorted and extracted from the beach berm materials. It is evident in Figure 1 that Red Cove Lake drains through the beach berm, even when a free-flowing outlet stream exists.

The Red Cove Lake outlet (Figure 1) on 14 September 1992 was effectively blocked to prevent anadromous salmon migration by large, cobble-size (20-30 cm), smooth surface rocks (Appendix A) (Figures 2, 3, and 4). Water from the lake was percolating through the rocks at several points along the beach area adjacent to the lake. Adult coho salmon were observed jumping in the bay adjacent to the lake, and young salmonid fry were observed in the lake near the former lake outlet. It is apparent however, that under natural conditions, this blockage may be intermittent. Hauser (Appendix A) reported during an earlier investigation that the outlet stream from Red Cove Lake was free-flowing. It was approximately 6-8 in. deep and 10-12 ft. wide. Adult coho salmon were observed in the lake at that time. Also, on 9 September 1981, the outlet stream from Red Cove Lake was well-defined and functional (Figure 1).
